FAST WRAP PRODUCTIONS LLC

STEEL CONDUIT AND PIPE WRAPPING SERVICE

March 2010

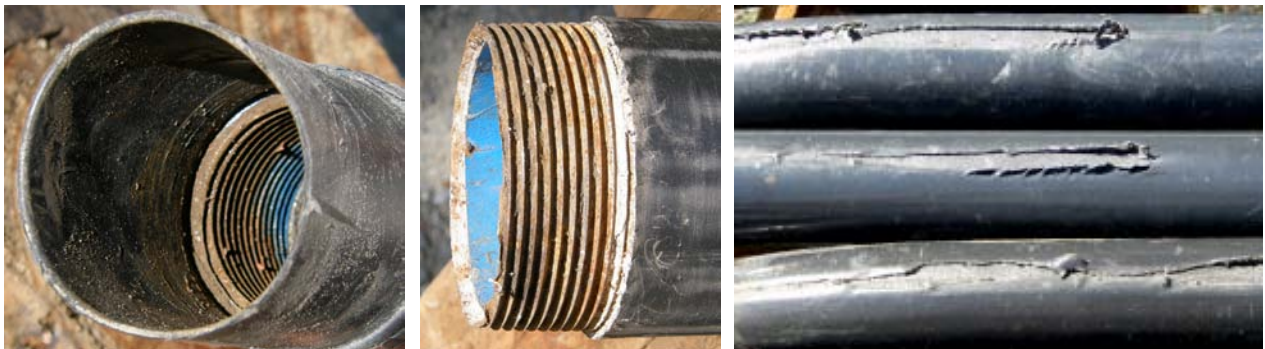
Recently a construction project in the San Francisco Bay area was halted due to financial problems. Six months later the work resumed and the new contractor found significant corrosion had taken place in the underground coated steel conduit especially at threaded connections due to many factors including "loose" threaded connections and the underground conduit work was deemed to be unusable. Damage was also noted on the external coating due to incorrect installation protocol.

Much of this could have been avoided using our procedure, triple wrapping with 20 mil tape of the pipe body and molded sleeves over threaded joints ensures a perfect seal.
